# NCST Investigation of the Champlain Towers South Collapse

## Investigation Overview and Update

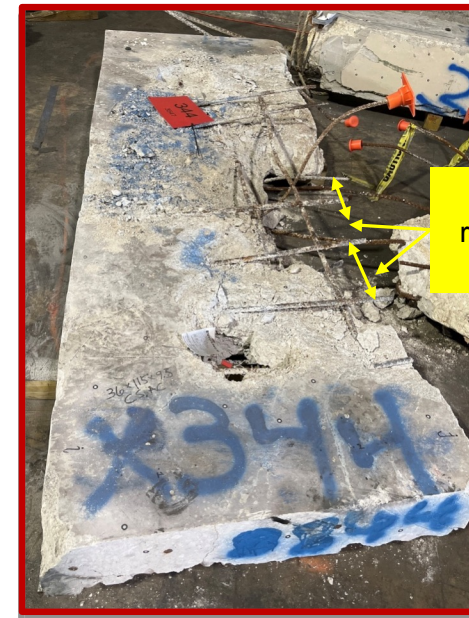
The measured spacing of the top reinforcing bars in the column strips of the pool deck slab specimens commonly ranges from about 20 % to 40 % wider than required by the structural design drawings, resulting in less reinforcing in the column strips than required by the design.

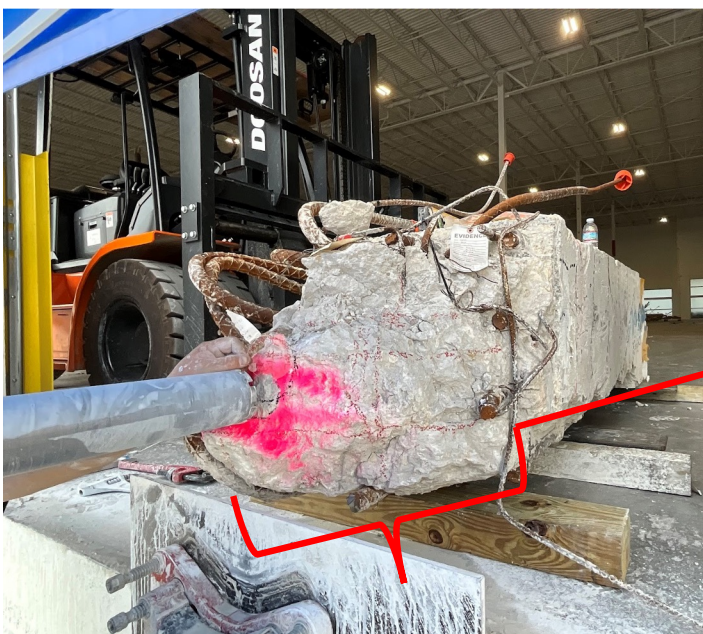
### Phase 2B

- 135 additional cores
- Special focus on concrete properties in slab-column connections at interface between pool deck & tower

- 301 cores and other concrete subsamples extracted
- 77 cores tested for compressive strength
  - Average strengths for structural element type populations exceed specified design strength\*
- 8 cores tested for modulus of elasticity\*\*
- 16 cores currently being subjected to materials-related tests\*\*
- 10 reinforcing bar subsamples extracted and tested for tensile properties\*\*

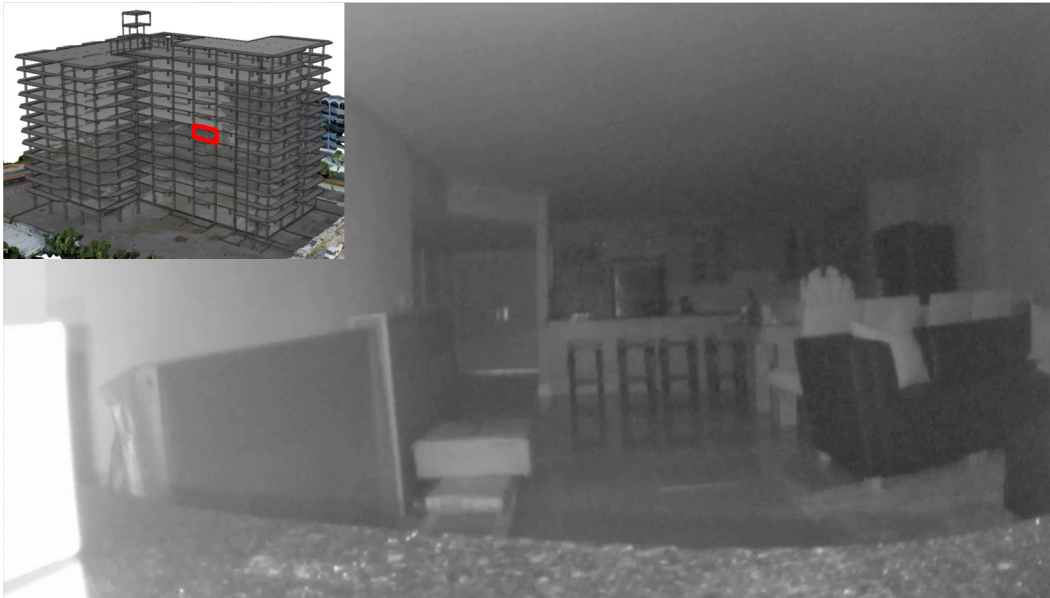
- Unit 711 video (looking north) captured movement during the collapse.
- Evaluating motion in video to aid in determining initiation and progression of tower collapse.

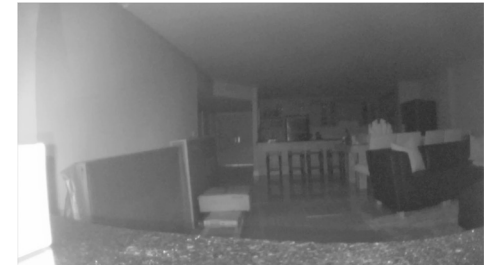
Initial event triggers recording but does not capture any motion.

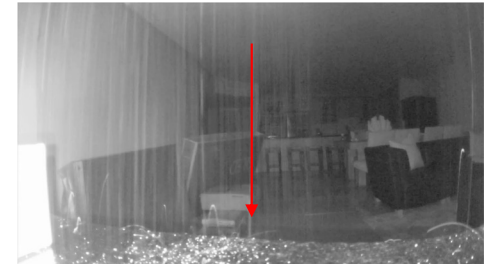
Second event triggers recording. Material from above falls straight down.

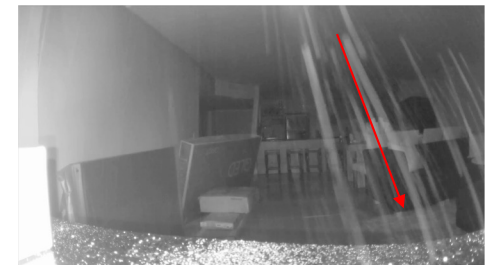
As video progresses, material from above falls at an angle; features in the background become distorted.

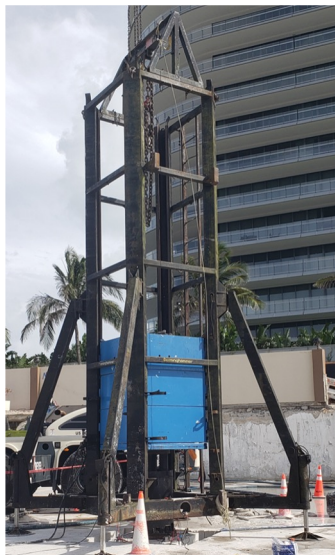
### Site-Specific Pile Testing

In two post-collapse load tests of piles in pool deck area, piles performed well and demonstrated adequacy to carry estimated design loads. Results are in agreement with literature for regional load tests with similar Franki piles, subsurface conditions, and load conditions.
